BABIL RAILWAY STATION REHABILITATION HILLA, IRAQ

SIGIR PA-05-019 MARCH 10, 2006

Babil Railway Station Rehabilitation in Hilla, Iraq

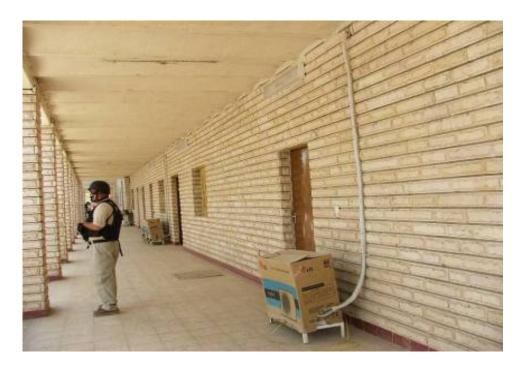
The contract's BOQ required the supply and installation of 100 square meters (m²) of Shafqueem facing brick and 115 m² of brickwork. We observed new facing brick and brickwork on the complete front and rear sections of the Babil Railway Station and around the supporting columns of the front and rear breezeway area. Installation of facing brick appeared to be consistent with the requirements of the contract.

Site Photo 1. Facing Brick on Rear Wall and Columns

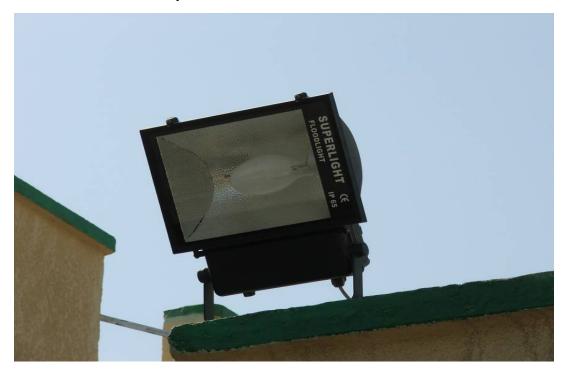
The contract's BOQ required the supply and installation of 124 double 2x40 watt (w) fluorescent luminar type F-I interior lights and wiring, and the supply and installation of twelve outdoor 250 w type FL12 lighting fixtures. In addition, the BOQ required the electrical wiring of sixteen 24,000 British Thermal Unit (BTU) air conditioning (A/C) split units, two 30,000 BTU A/C split units, and four 36,000 BTU A/C split units. During the site assessment, we observed new exterior lighting fixtures, interior lighting fixtures, and wiring for the A/C split units. We did not note any deficiencies concerning the electrical lighting and electrical upgrades.

Site Photo 2. Mounted Exterior Light Unit

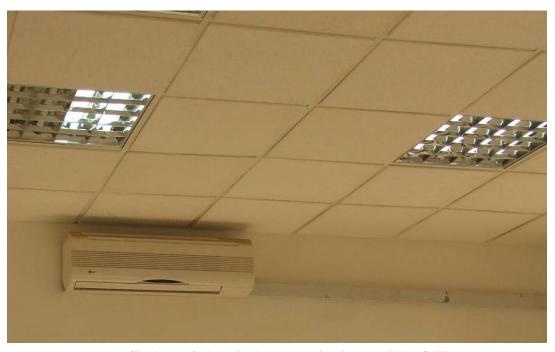
Site Photo 3. Interior Recessed Lighting and False Ceiling

The contract's BOQ required the supply and installation of 714 m² of false ceiling, consisting of Gypsum tiles on metal grid. During the site assessment, we observed installed false ceiling tile in all three of the interior rooms visited. The installation of false ceilings appeared to be consistent with the requirements of the contract. Site Photo 3 shows the false ceiling inside the Babil Railway Station.

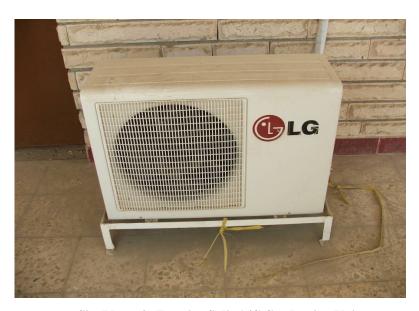
The contract's BOQ required the supply and installation of sixteen 24,000 BTU A/C split units, two 30,000 BTU A/C split units, and four 36,000 BTU A/C split units. We observed new split A/C units (condensing unit located on the exterior and cooling/blower unit in the interior) at the Babil Railway Station. Electrical connections were completed; however, operation of the A/C units was not verified. See Site Photo 4 shows the exterior condensing unit of 24,000 BTU LG Industries, LTD A/C split unit, which was located in the rear of the railway station. A cooling/blower unit mounting in an interior office of the railway station can be seen in Site Photo 5. Installation of A/C units appeared to be consistent with the requirements of the contract.

Site Photo 4. Exterior Split A/C Condensing Unit

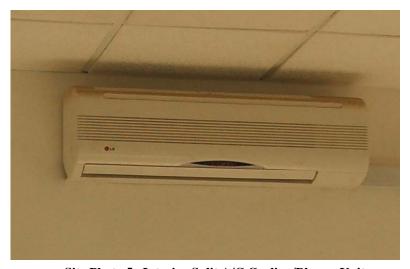
Site Photo 5. Interior Split A/C Cooling/Blower Unit

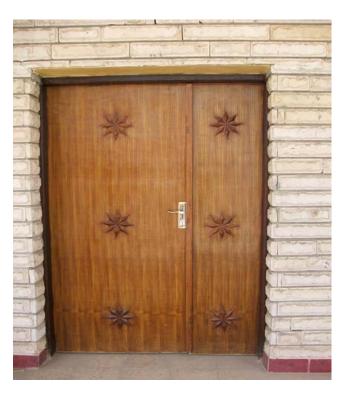
The contract's BOQ required the supply and installation of thirty heavy wood doors and frames, eight new aluminum windows, and the repair of twenty-nine windows. During the site visit we observed installed windows, which appeared new, and new and/or refurbished doors. No deficiencies were noted; however, only a small percentage of the doors and windows were inspected.

Site Photo 6. Exterior Wooden Door

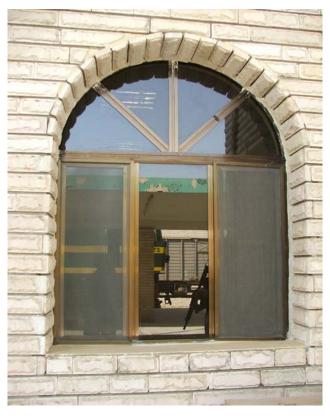
Site Photo 7. Rear Exterior Aluminum Window

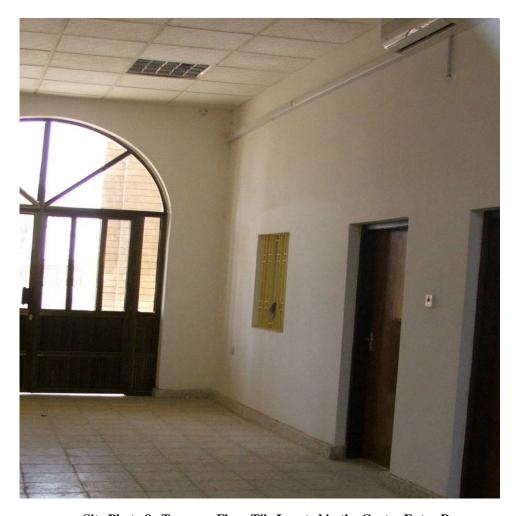
The contract's BOQ required the supply and installation 1342 m² of ceramic and terrazzo floor tile and 178 m² of ceramic wall tile. During the site assessment, we observed installed tile in all three of the interior rooms visited. The Babil Railway Station Manager stated he was not pleased with the choice of tile and the tile surface was not cleaned properly. The USACE QAR on site during the assessment said the previous station manager and engineer selected the tile. The installation of tiles appeared to be consistent with the requirements of the contract.

Site Photo 8. Terrazzo Floor Tile Located in the Center Entry Room $\,$
